# The Church of Saints Sergius and Bacchus in Kaftūn (Northern Lebanon) and Its Wall Paintings

*Preliminary Report 2009–2010*

TOMASZ WALISZEWSKI | KRZYSZTOF CHMIELEWSKI  
MAT IMMERZEEL | NADA HÉLOU

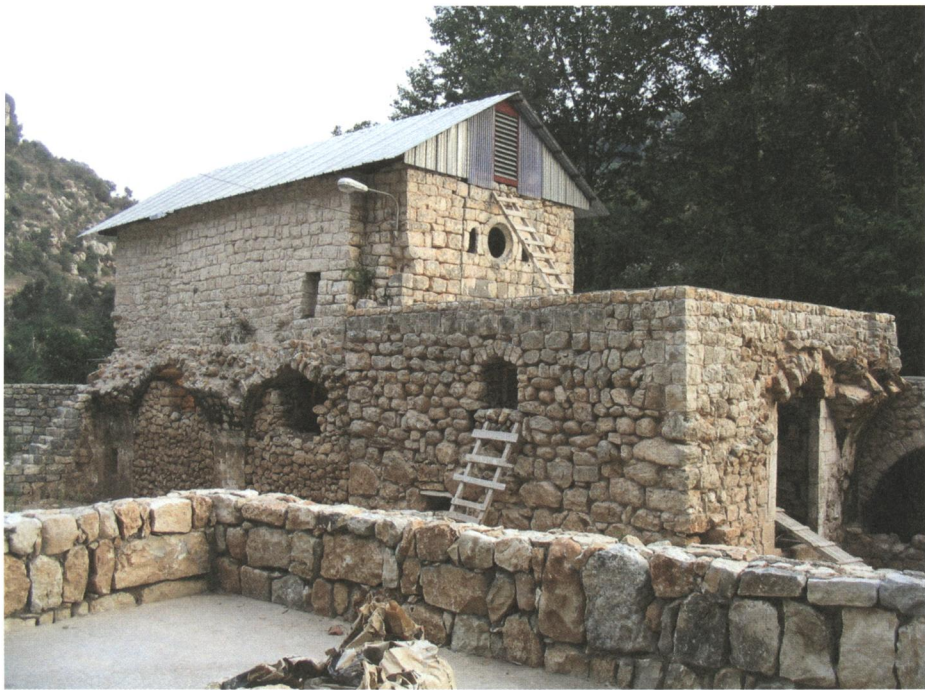
FIG. 2  
The Church of SS. Sergius and Bacchus during conservation work. The temporary roof raised over the church and the stone-filled arcades of the north wall can be seen (K. Chmielewski).

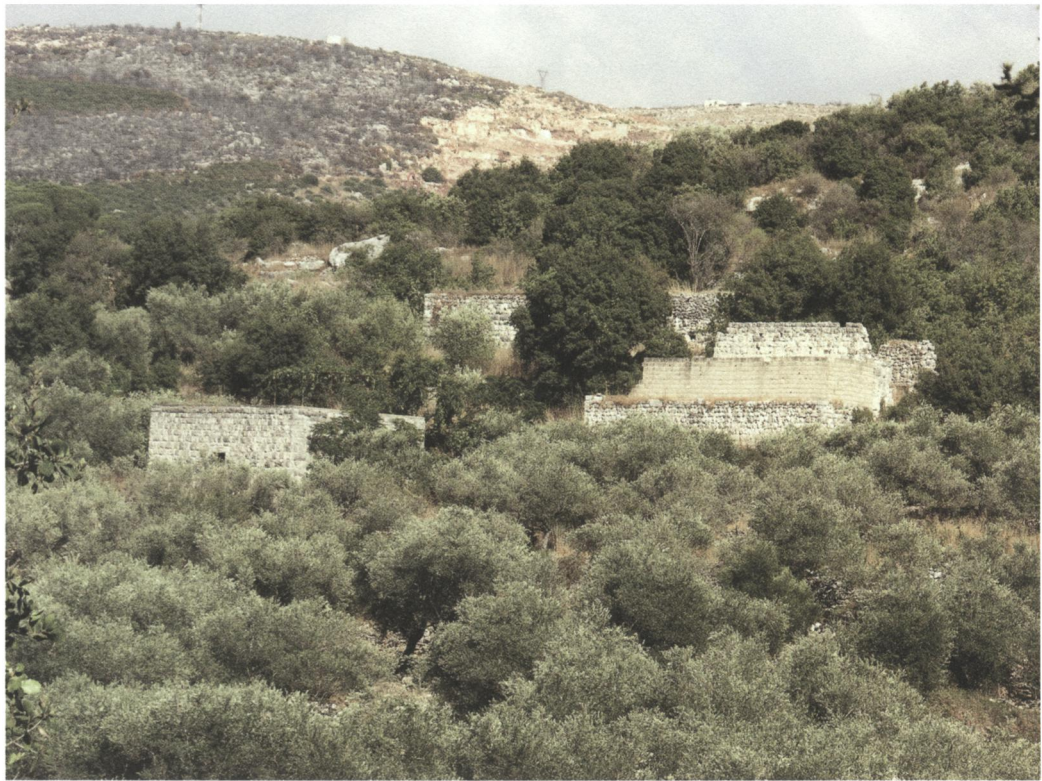
FIG. 5  
Stone buildings  
in the river valley,  
below the monastery  
(T. Waliszewski).

a few houses. Due to the absence of any comparable architecture from the region, we can classify them only as typical rural dwellings from the late Ottoman and Mandate period, until recently rarely recorded during archaeological or ethnographic research in Lebanon. The settlement itself, due to its proximity, probably had close ties with the monastery. Future detailed analysis of these structures will be necessary to better comprehend the context of the church, as well as the extent of the monastery and its economic foundations (figs. 5–6).

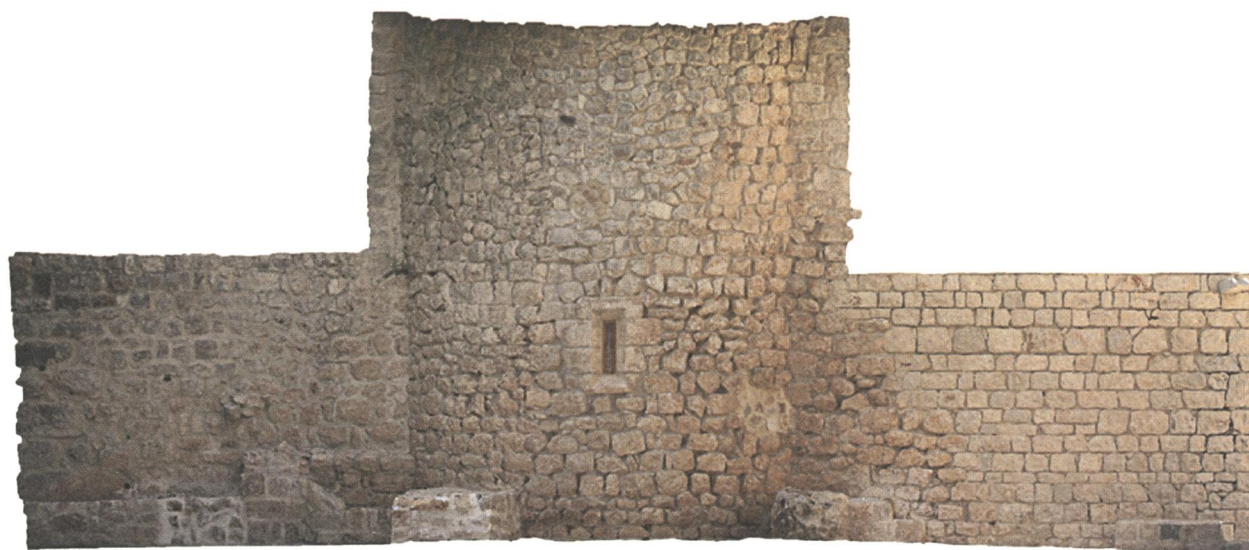
FIG. 9 Eastern elevation of church with apse (M. Gładki and K. Czajkowski).

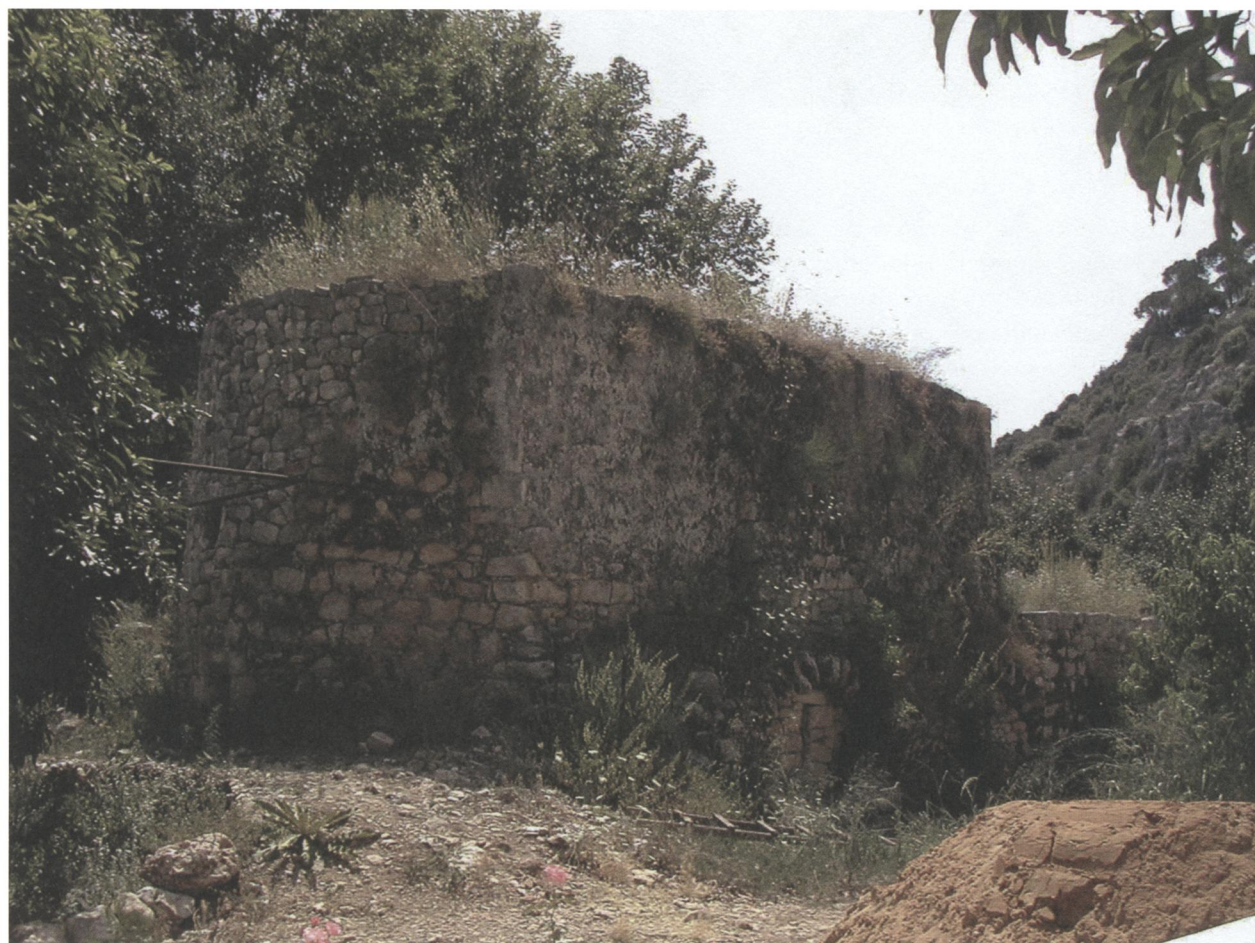
FIG. 10 The Church of SS. Sergius and Bacchus prior to conservation work (courtesy of S. Sabbagha).

The church interior also underwent severe deterioration, resulting in the complete destruction of the floor. The walls and vaults were coated with dirty, damaged plaster of a greenish-grey hue. The plaster surface was covered with drip marks and numerous stains resulting from the effects of damp and from the growth of microorganisms. Plants had laid down roots between the plaster layers, causing them to crack and become delaminated from the wall surface in many places.

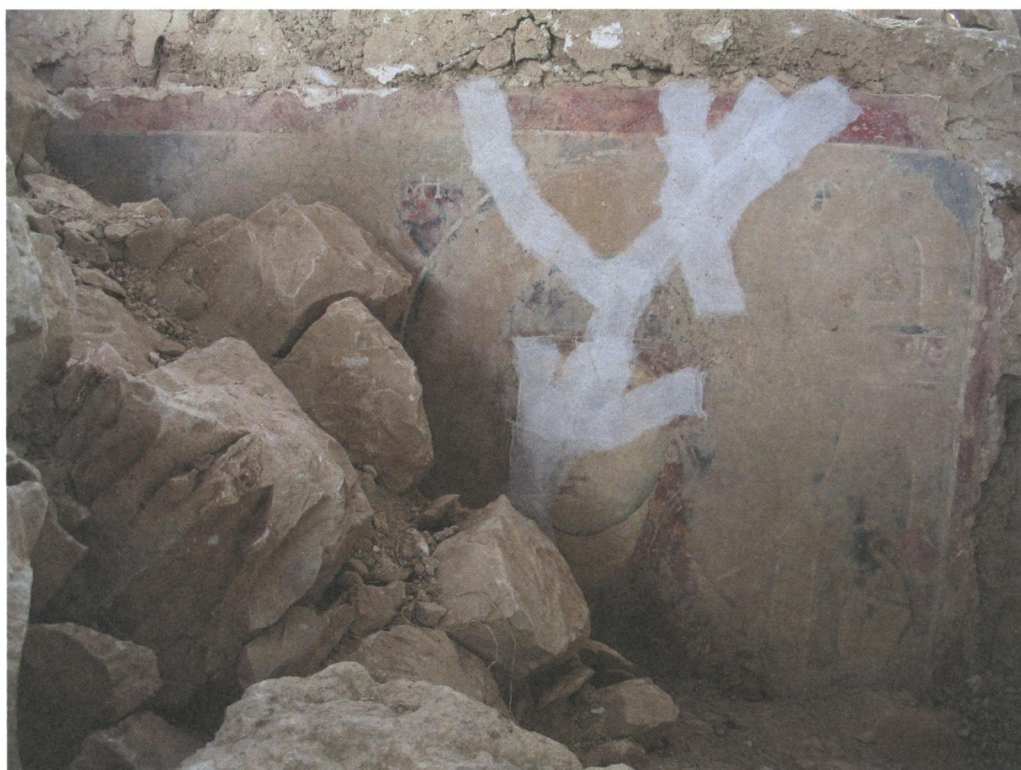
FIG. 11

Fragment of a wall painting discovered in 2003 above the church's vaulting. Secured cracks on the painting's surface can be seen (K. Chmielewski).

In 2003, when work began on clearing the soil and rubble covering the outer roof surface, two fragments of wall painting came to light above the apse. It was where the wall paintings were found rather than their discovery per se which was surprising. There could be only one explanation for this intriguing location of the uncovered mural fragments—on an exposed, outer wall, above the level of the vaulting. The existing barrel vault above the nave is not original, and must have been installed following the collapse of an earlier vault. The symmetrical downward sweep of the new vault's frontal arch divided the composition into two separate parts, while also partially obscuring it. The face of a youth encircled by a halo began to emerge from beneath the soil and rubble on the left (north) side. The fragment visible on the right (south) side was a depiction of the face of the Virgin Mary framed by a maphorion, with two poorly discernible,

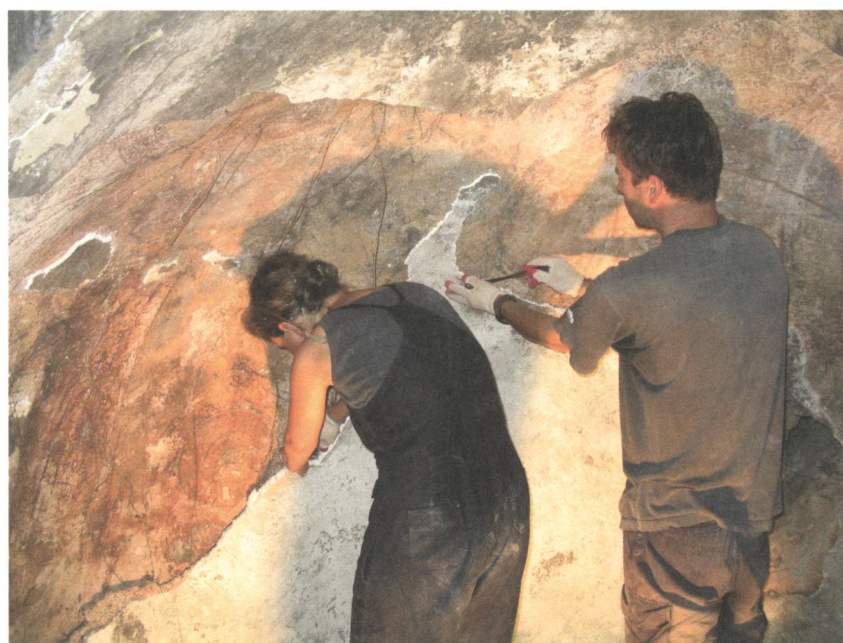
FIG. 12  
Uncovering of the paintings  
in the upper section of the  
apse (T. Waliszewski).

chisels, knives, flat spatulas, and hammers (figs. 12–13). Careful removal of the top plaster coat gradually and systematically revealed increasingly large areas of the underlying strata. After a week's work the secondary plaster in the upper section of the apse above the cornice had been completely removed, revealing a Deesis scene depicted as an Apocalyptic Vision. Christ Pantokrator holds an open book in his left hand, his

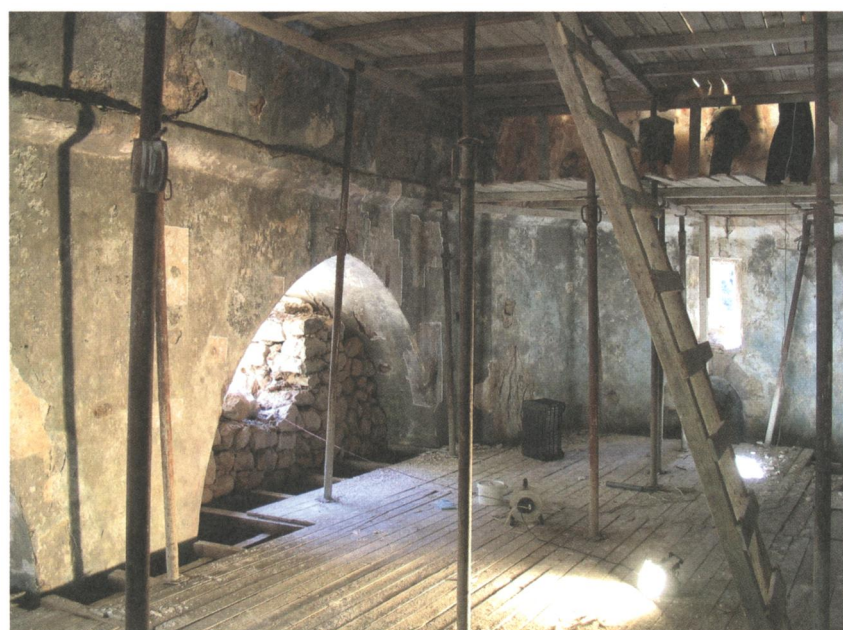
FIG. 13  
Removal of secondary  
plaster from the walls of  
the nave (T. Waliszewski).

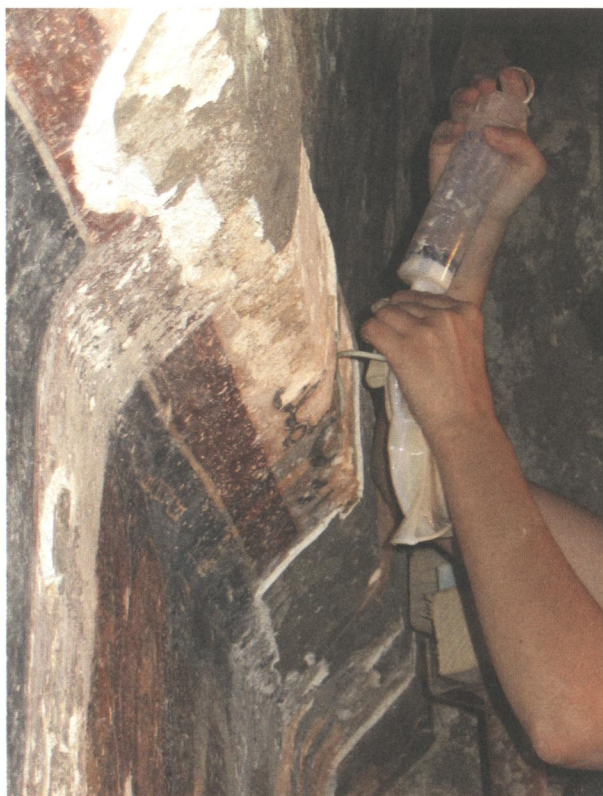
FIG. 14 Consolidation of the plaster in the nave (M. Baran).

From the start, conservation work on the wall paintings in Kaftūn was carried out while successively uncovering them. The paintings were severely damaged and under serious threat of further deterioration. The primary danger was posed by extensive internal delamination of the plaster layers, which in many areas were at risk of losing all adhesion with the underlying stone substrate. The plaster strata were consolidated using multiple injections of specialist mineral binding agents (fig. 14). The structure of the compromised plaster edges on the extant fragments of wall painting were additionally reinforced by impregnating them with a water-soluble synthetic resin. These edges were subsequently secured with fresh mortar.

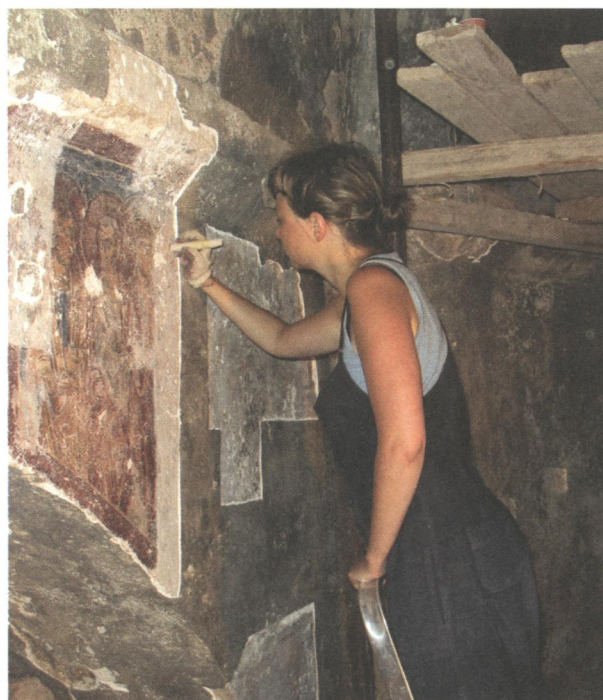
FIG. 15 Cleaning the surface of wall paintings on the north wall of the nave (M. Baran).

A serious problem faced by conservators was how to tackle the process of cleaning the painted surfaces of the hard coatings formed by secondary crystallization of water-soluble salts. Many areas of the wall paintings were covered in a thick layer of calcite. When lime plaster is exposed to high moisture levels for long periods of time decarbonation of calcite takes place within the plaster as the calcite is carried outward with the water, after which the process of recarbonation takes place on the painted surface. This type of damage is very common in this region, a result of the walls being exposed to heavy rainfall in autumn and winter, and then drying out in the prevailing high temperatures of spring and summer. The frequent repetition of this process, along with the vaults and roofs not being waterproof and the walls being inadequately

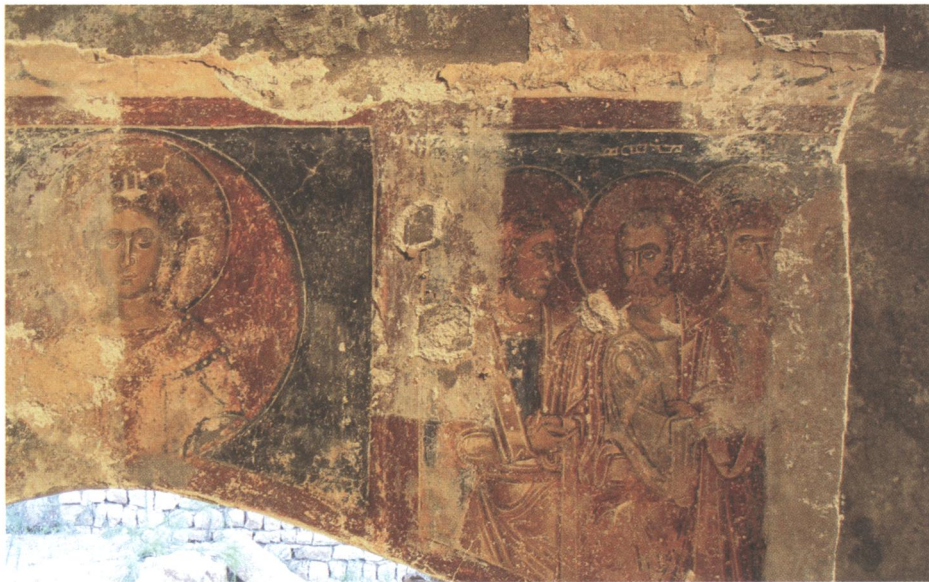
FIG. 16  
Frescoes on the north wall of the nave were revealed by removing secondary layers of plaster, and their painted surfaces were cleaned (M. Baran).

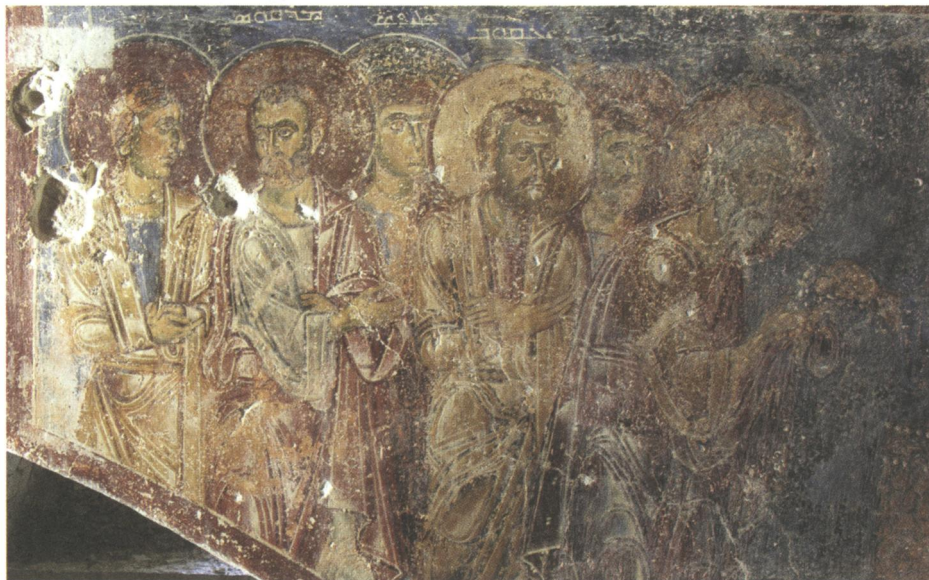
FIG. 17  
Detail of the Communion of the Apostles on the north wall seen during the final phase of cleaning its painted surface (M. Baran).

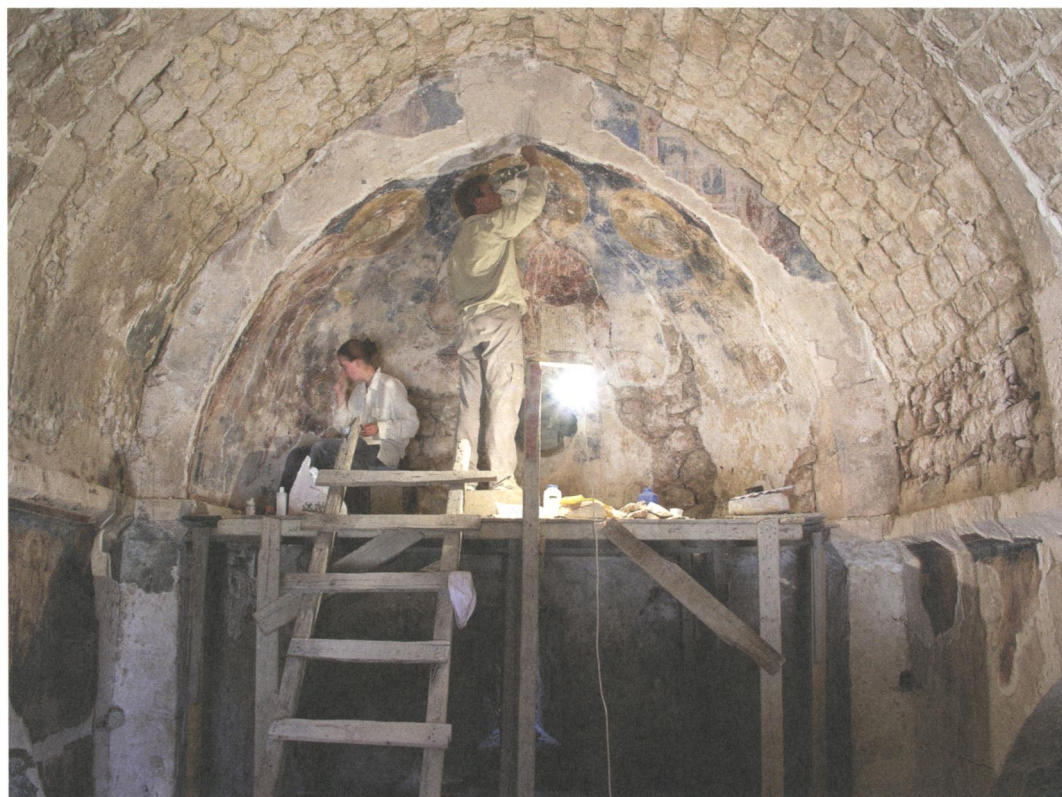
FIG. 18  
Final stage of  
conservation  
treatment of the  
wall paintings  
in the apse  
(A. Maciejewski).

damp-proofed, exacerbates the negative effects. Removing the calcite by chemical methods alone without exposing the paintings to additional damage is impossible. The only alternative is to carry out the labor-intensive, time-consuming, and painstaking task of carefully controlled mechanical cleaning, chiefly using surgical scalpels (figs. 15–17). The results obtained using this method of cleaning at Kaftūn proved to be satisfactory. However, comprehensive cleaning of a wall painting's surface was not pursued on those parts of the paint layers that may have been endangered by this procedure. Where appropriate,

particularly in those areas painted using red pigments, the powdering paint layer was consolidated by impregnating it with acrylic resin (fig. 18). The decisions undertaken regarding the ultimate appearance of the paintings after conservation had to reconcile the requirement that their authenticity be preserved with their aesthetic appearance inside the church, taking into account its reinstatement as a place of worship. In view of the artistic merit and historic significance of the murals, any attempt at reconstructing their artistic form would be unacceptable. Thus, work was limited as far as possible to procedures aimed

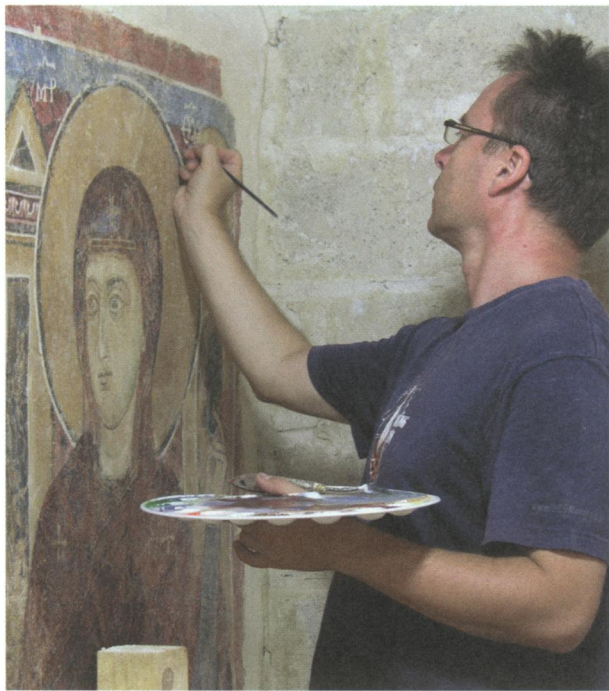
FIG. 19 Retouching of the paint layer of the Annunciation scene (R. Tusznió).

exclusively at consolidating and securing the paintings. Where it was feasible to make the form more legible, limited retouching of the paint layers was performed. All retouching was executed so that it visibly differed from the original strata. A distinctly lighter shade than the surrounding color was used to fill very small losses. Larger losses were retouched using the *tratteggio* technique, which allows the retouched area to be identified at close range as a series of closely spaced vertical brushstrokes of color that from a distance blend in with the composition as a whole. All retouching was carried out using pigments with a synthetic, reversible binding medium, making them easy to remove (figs. 19–20).

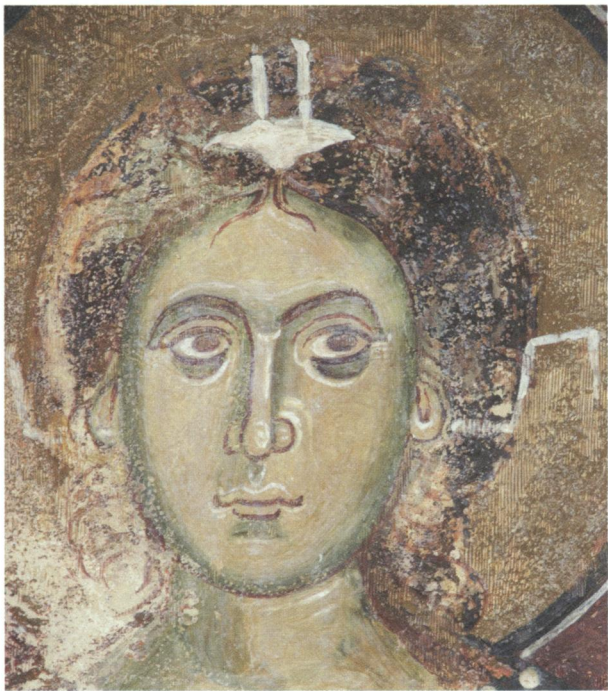
FIG. 20 The face of an archangel on the north wall after conservation. *Tratteggio* retouching of the paint layer is evident (R. Tusznió).

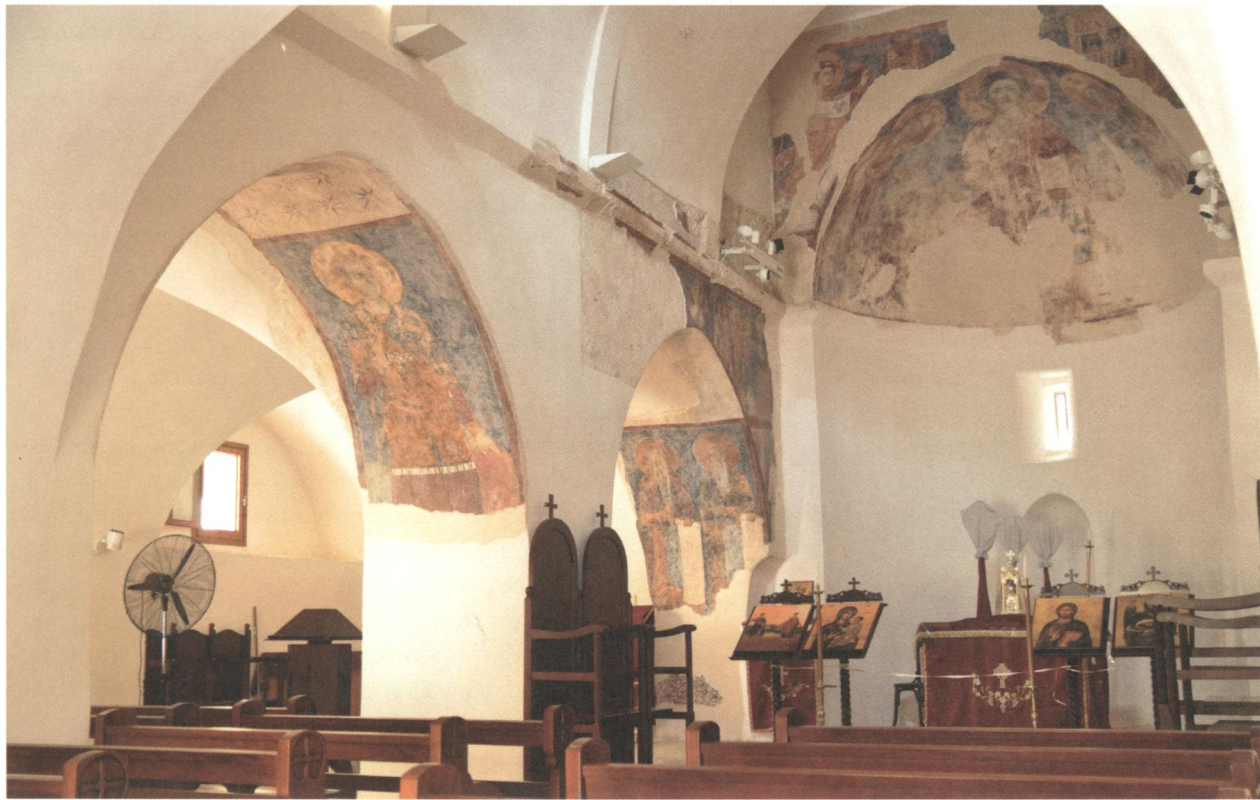
FIG. 21 The church interior on completion of conservation work (R. Tusznió).

Over the years, renovation work on the church building took place concurrently with the conservation of the wall paintings.<sup>14</sup> The north aisle was rebuilt using the south aisle as a model. The walls were structurally reinforced and a water drainage system was installed beneath the church's new floor. The temporary metal roof having been removed, a lightweight flat roof was raised above the main body of the church. Inside, wall surfaces with no extant paintings were coated with a fresh layer of white lime plaster. The church was opened for worship on completion of all conservation work in 2009. The discovered and salvaged wall paintings are its highly prized and most significant decoration (fig. 21).

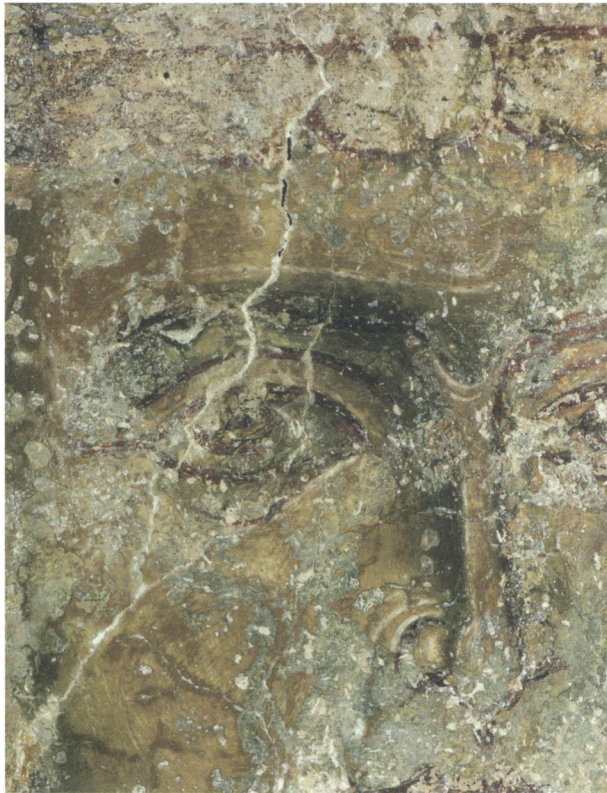
FIG. 24 Detail of the face of St Bacchus after cleaning. Layers of green underpainting can be seen in the shadows around the nose and eye (R. Tusznió).

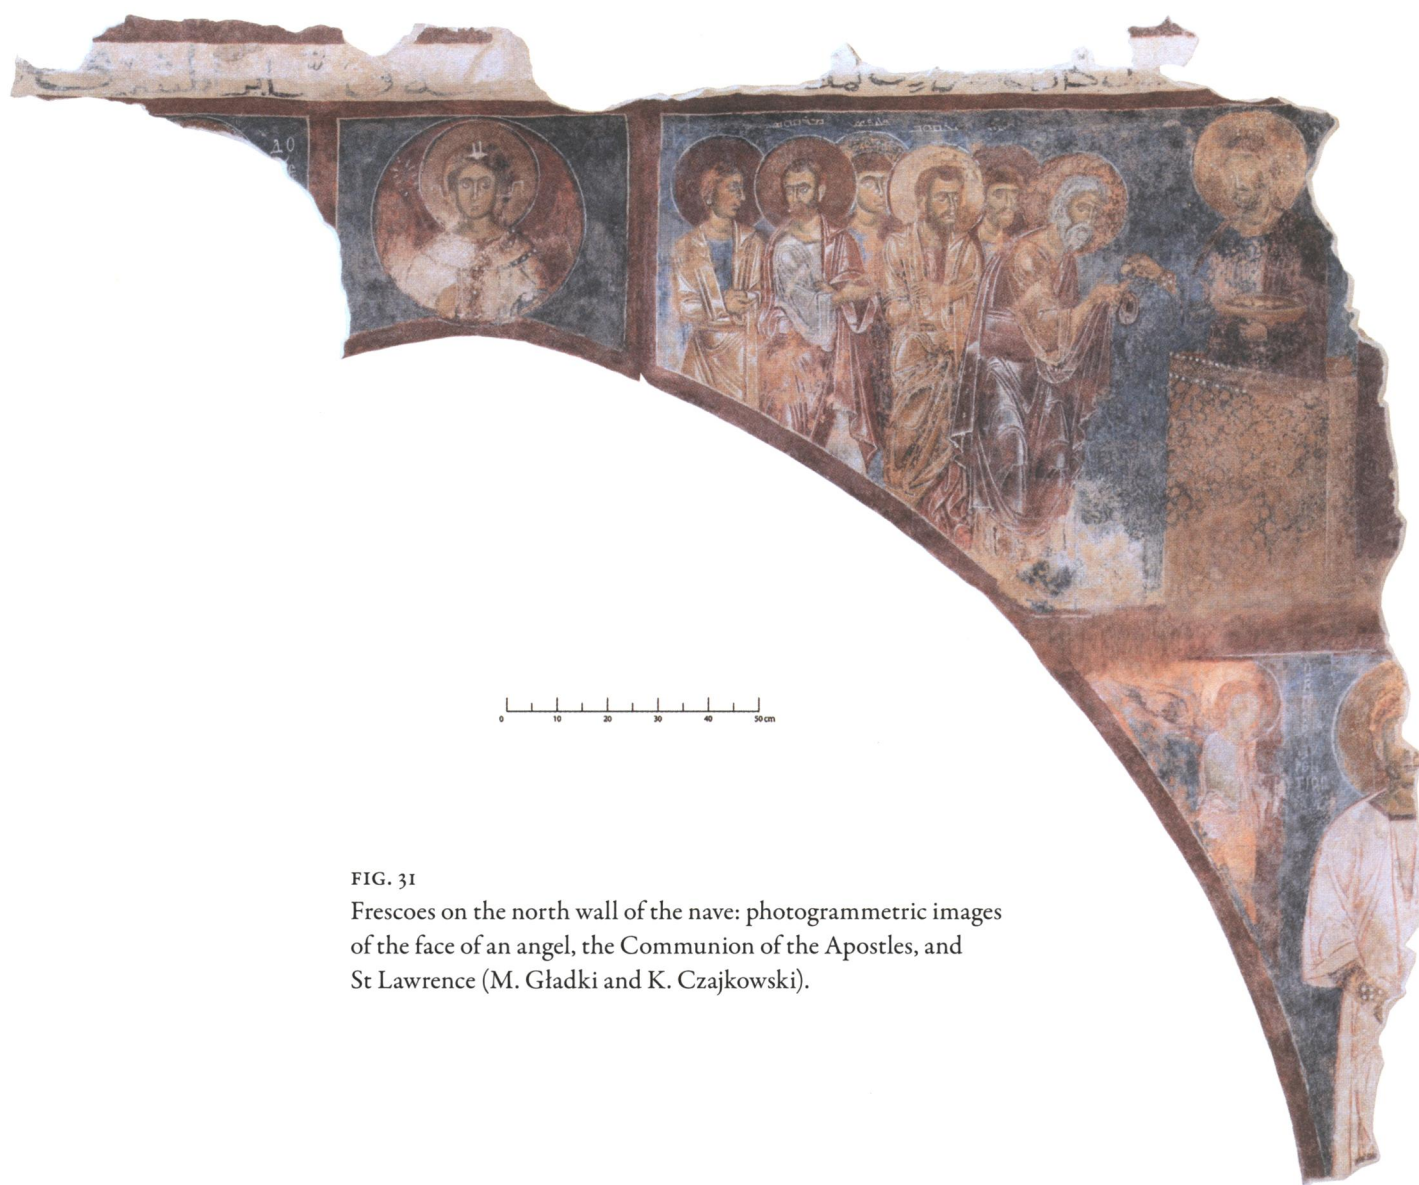
FIG. 31  
Frescoes on the north wall of the nave: photogrammetric images  
of the face of an angel, the Communion of the Apostles, and  
St Lawrence (M. Gładki and K. Czajkowski).
